A Successful Root Canal Therapy of a Maxillary Lateral Incisor With 2 Root Canals: A Case Report

Case Presentation: This case report describes successful endodontic management of an uncommon variation of the maxillary lateral incisor with two root canals. Based on the clinical and radiographic findings, pulp necrosis and symptomatic apical periodontitis were diagnosed. The tooth received root canal treatment. The patient was followed up for 6 months and clinical and radiographic examinations in the follow-up sessions showed improvement in the periapical condition and the tooth became asymptomatic.

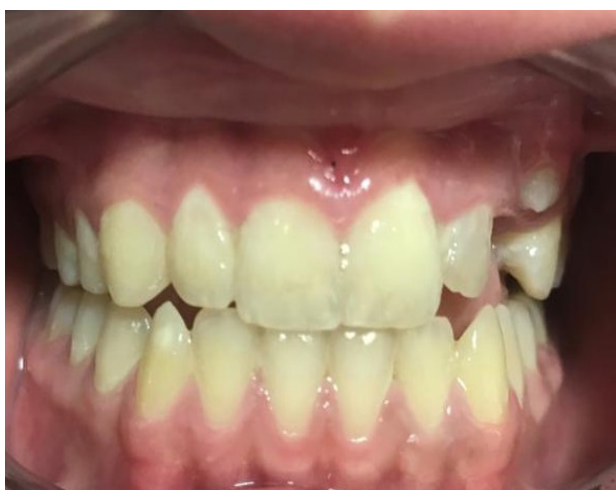
Figure 1. Clinical picture depicting normal anatomic form of right and left maxillary lateral incisors

An 11-year-old girl with a complaint of tooth sensitivity when chewing referred to Hamedan School of Dentistry for root canal treatment of the left maxillary lateral incisor (Figure 1). Clinical examinations indicated normal dimensions of the lateral incisor crown on both sides. Moreover, there was no evidence of a developmental radicular palatal groove. In addition, the tooth did not respond to vital pulp tests and was sensitive to percussion. Radiographic examination showed caries in the mesial aspect of the crown. Actually, the mentioned tooth had abnormal root morphology with two separate roots

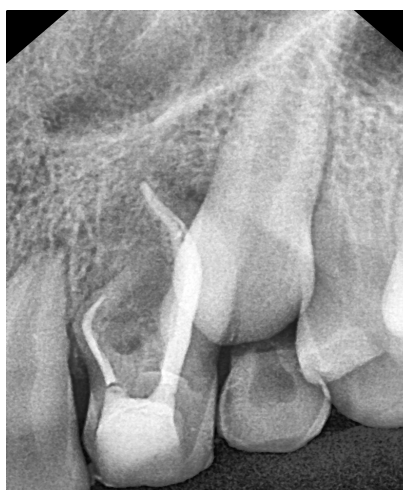
Figure 3. Final radiograph after root canal therapy

Ballaigues, Switzerland) to size 40 for the distal root and 25 for the mesial root. It is notable that the canals were constantly irrigated with 5.25% sodium hypochlorite solution. Finally, after drying with a paper point, the canals were obturated with gutta-percha (Gapadent, China) and AH26 sealer (Dentsply-Maillefer, Ballaigues, Switzerland) by lateral condensation technique (Figure 3). Then, glass-ionomer cement (GC, Japan) was used as a temporary filling material and after the final radiography, the patient referred to the restorative department for the final restoration. The patient was followed up for 6 months and clinical and radiographic examinations in the follow-up sessions showed improvement in the periapical condition and the tooth became asymptomatic (Figure 4).

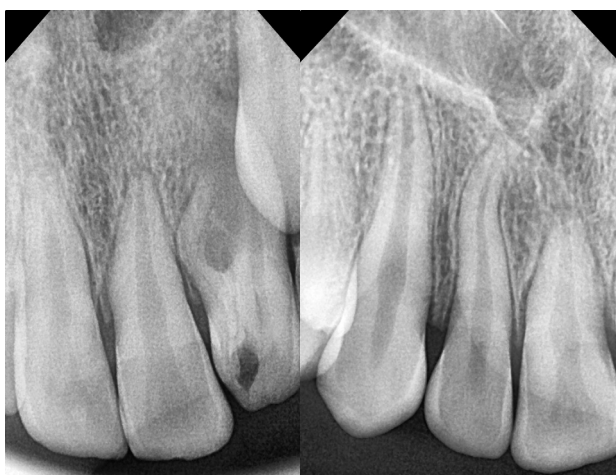
Figure 2.(a) preoperative radiograph showing an extra root in relation to left maxillary lateral incisor, and (b) contralateral tooth with normal morphology

(mesial and distal), whereas the contralateral tooth had normal morphology. Furthermore, radiolucency was seen around the mesial root (Figure 2). Based on the clinical and radiographic findings, pulp necrosis and symptomatic apical periodontitis were diagnosed. Following a discussion with the patient and her parents and obtaining informed consent from the patient's parents, non-surgical root canal treatment was planned. After infiltration anesthesia with 1.8 mL of 0.2% lidocaine with 1:80 000 epinephrine, the tooth was isolated using clamp and rubber dam and access cavity preparation was done using high-speed diamond bur under water spray conditions. Then, the working length was measured by the apex locator (Root ZX, Morita, USA) and was confirmed by radiography. The canals were cleaned and shaped using the crown-down technique with Protaper System (Dentsply, Maillefer,

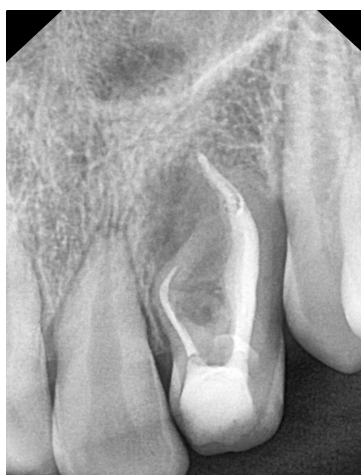
Figure 4. 6 months follow-up radiograph
